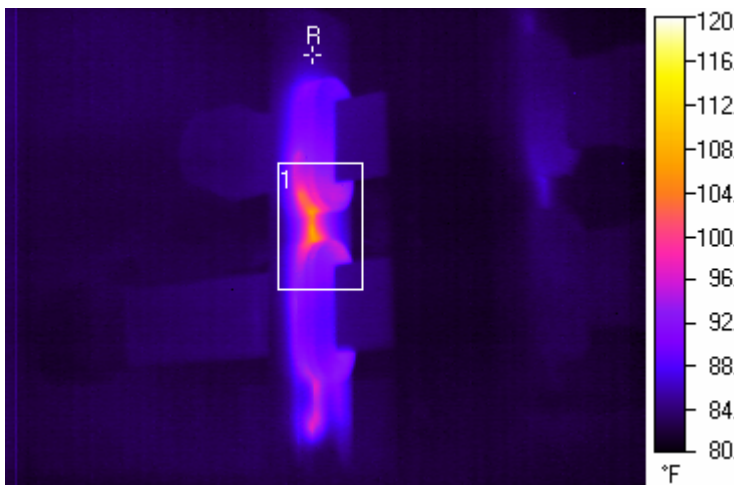
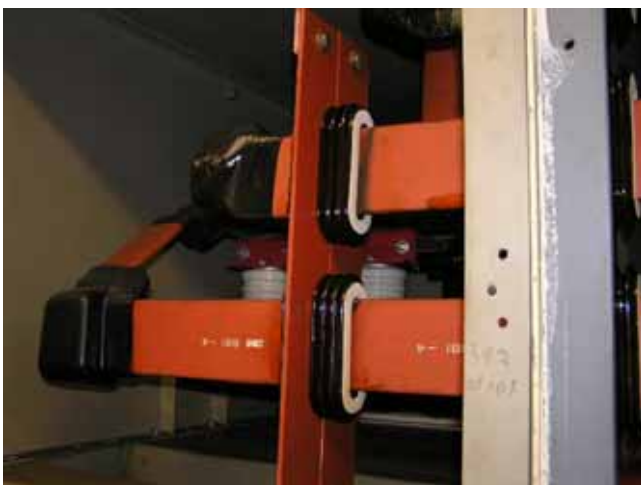
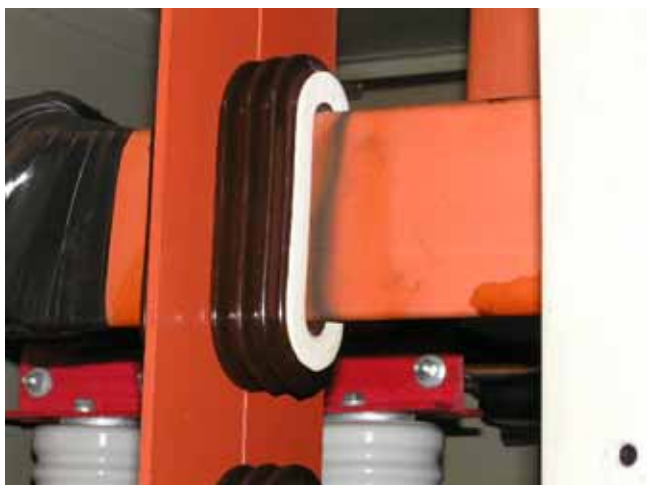
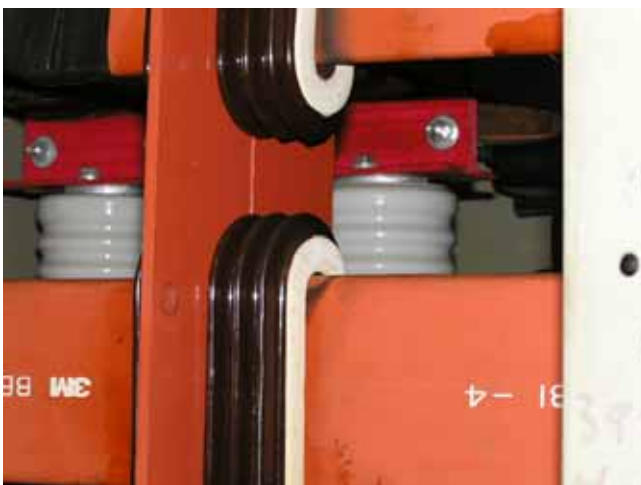
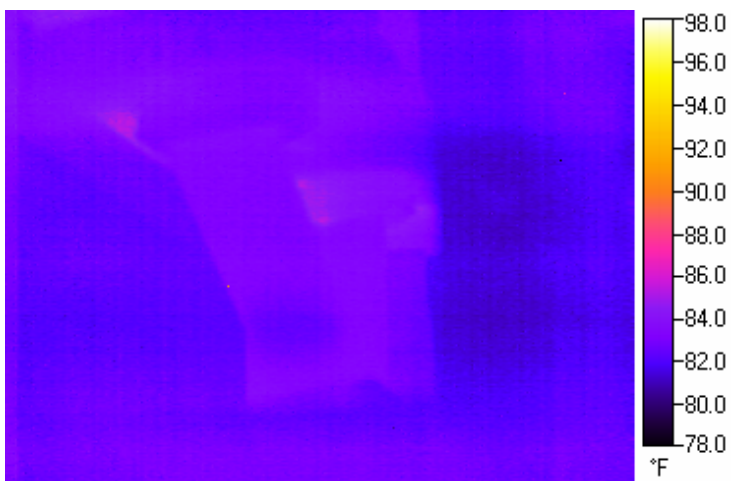
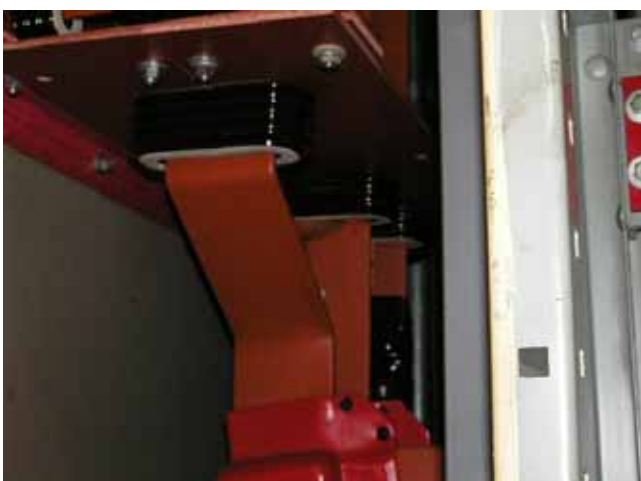
Comments: **A Great Find for Early Detection of Potential Problems.** The Top left thermal image has heat associated with discharge detected with the ultrasound Also notice the tracking marks above and below the warm area showing signs of tracking which are shown in the middle close up photos as well. The bottom image and photo revealed no heat but discharge was detected here as well with tracking marks also.
