ABSOLUTE INFRARED INSPECTION SERVICES 5043 West Lake Road Erie, PA 16505 814-835-9295	Thermal Diagnostics Report By: Craig Casler Level II Thermographer Level II ASNT
------------------------------------------------------------------------------------------------	-------------------------------------------------------------------------------------------

Customer:	XXXXXXXXXXXXXX
Date:	July 25, 2006
Location:	Exterior
Equipment:	Pad Mounted Transformer
Component:	H3 A
Voltage:	N/A
Amp / Load	N/A
I.D. #

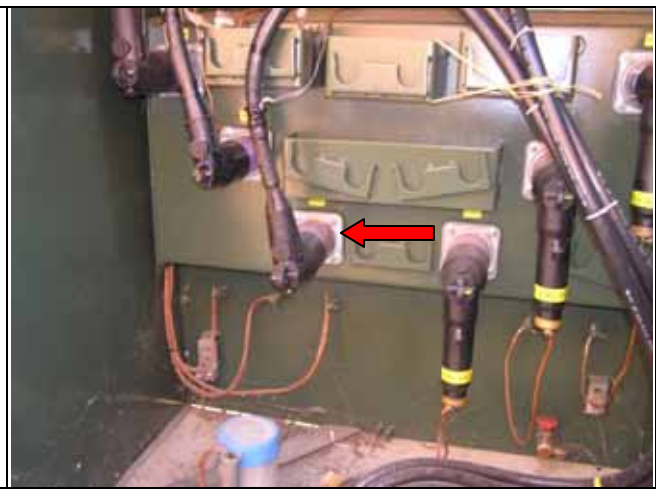
Comments: The corona discharge was verified with the corona camera. The perimeter of the H3 pistol grip at the top of the metal plate is the location of the arching. Black arching marks surround the perimeter of the pistol grip on the metal plate.
